# Manhole Inspection Summary

Manhole # S49U1\_004MH

Insp Date: **6/4/08 9:52 AM**

**Location** Address: **3100 Frankfurst Ave.**

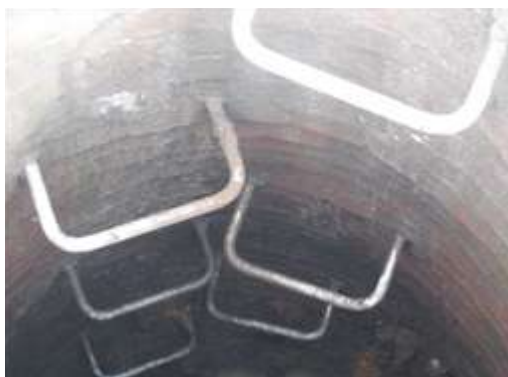
Steps

**Steps** Count: **6** Missing: **0** ☐ Corroded

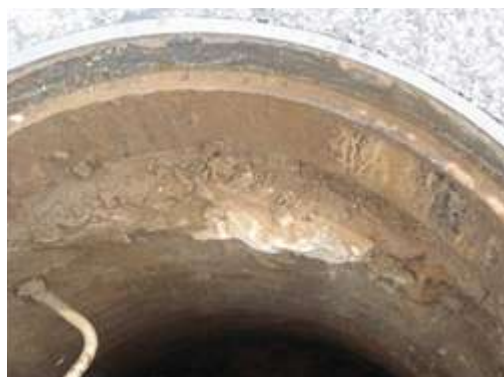
Defect 1

**Frame** Offset: **3** (in.) Condition: ☒ Sound ☐ Cracked ☐ Leaks

Condition: ☐ Sound ☐ Cracked ☐ Root Intrusion ☐ Loose Brick ☒ **Deteriorated**

Infiltration: ☐ None ☒ **Joint** ☐ Cracks ☐ Mortar ☐ Roots ☐ Wall

Frame offset and deteriorated  
Frame-Chimney joint.

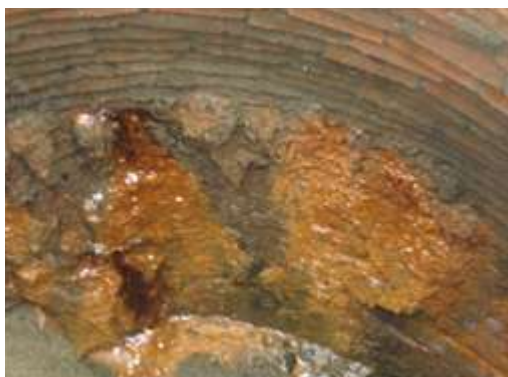
Defect 2

Condition: ☐ Sound ☐ Cracked ☐ Root Intrusion ☐ Loose Brick ☒ **Deteriorated**

Infiltration: ☐ None ☐ Joint ☒ **Cracks** ☐ Mortar ☐ Roots ☒ **Wall**

Infiltration and deteriorated barrel.

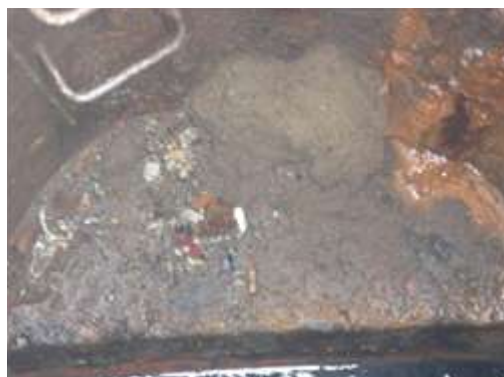
Defect 3

Condition: ☐ Sound ☐ Cracked ☐ Root Intrusion ☐ Deteriorated ☐ Leaks ☒ **Debris**

Debris on the bench.

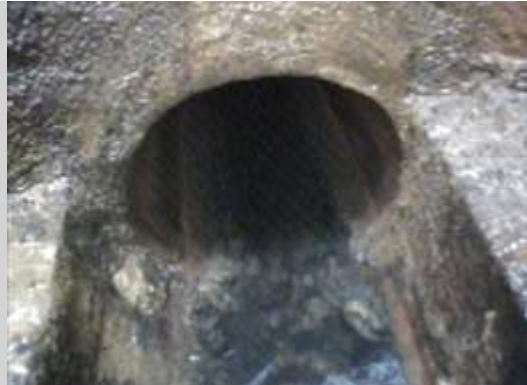
12 O'Clock Outflow

12 in. Circular Gravity Sewer  
Pipe Out @ 12 O'Clock

Pipe Height: **12** (in.) Rod and Bar (Angled)  
Pipe Material: **Clay** ☐ Pipe Lined  
Invert Depth: **11.68** (ft.) Flow Characteristics: **Fast**  
Deposits: ☒ None ☐ Mud ☐ Sludge ☐ Debris ☐ Grease  
Silt Depth: (in.) Deposits Extent:  
Infiltration: **None** Pipe Seal Cond: **Sound**

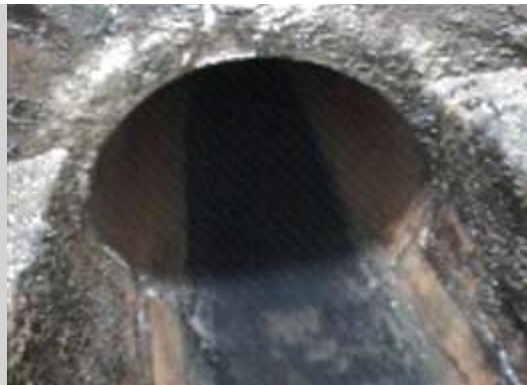
6 O'Clock Inflow

12 in. Circular Gravity Sewer  
Pipe In @ 6 O'Clock

Pipe Height: **12** (in.) Rod and Bar (Angled)  
Pipe Material: **Clay** ☐ Pipe Lined  
Invert Depth: **11.60** (ft.) Flow Characteristics: **Fast**  
Deposits: ☒ None ☐ Mud ☐ Sludge ☐ Debris ☐ Grease  
Silt Depth: (in.) Deposits Extent:  
Infiltration: **None** Pipe Seal Cond: **Sound**
